METROPOLITAN TRANSIT AUTHORITY OF BLACK HAWK COUNTY

Transit Asset Management Plan (TAM)

METROPOLITAN TRANSIT AUTHORITY OF BLACK HAWK COUNTY
Transit Access Management (TAM) Plan

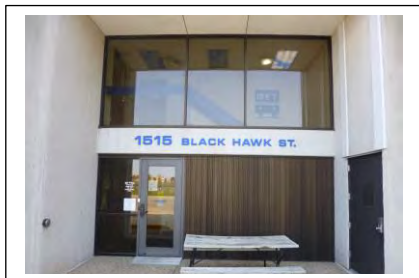
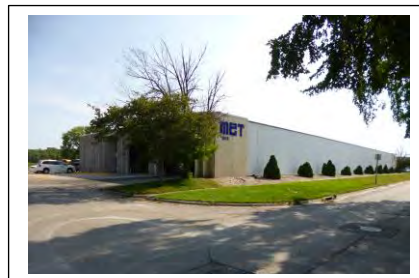
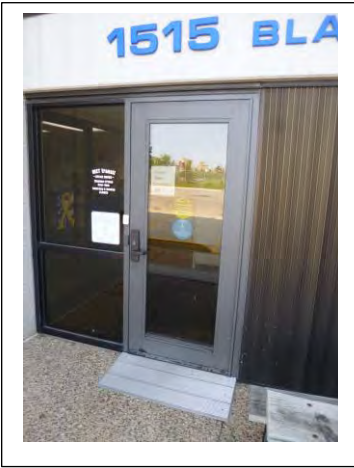
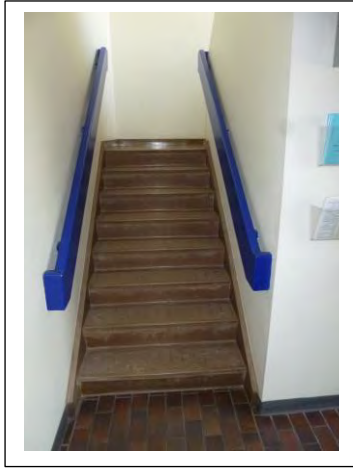
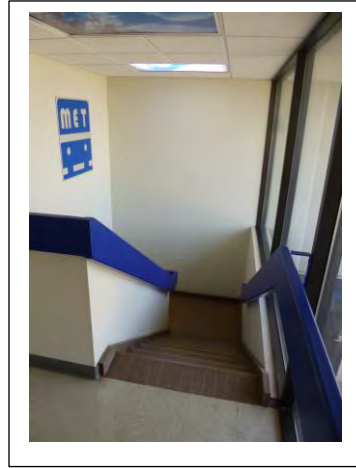
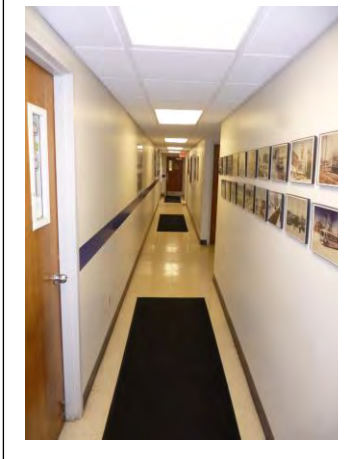
Combined Administrative and Maintenance Facility – Photos

Condition Assessment
Combined Administrative and Maintenance Facility
Overall Condition Rating: 3.54625

Substructure Subtotal	3
Shell Subtotal	3
Interiors Subtotal	3.67
Conveyance Subtotal	Not Applicable
Plumbing Subtotal	4
HVAC Subtotal	4
Fire Protection Subtotal	3.5
Electric Subtotal	4
Site Subtotal	3.5
Overall Conditional Rating	3.54625

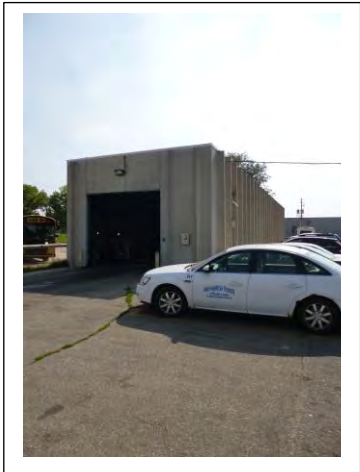
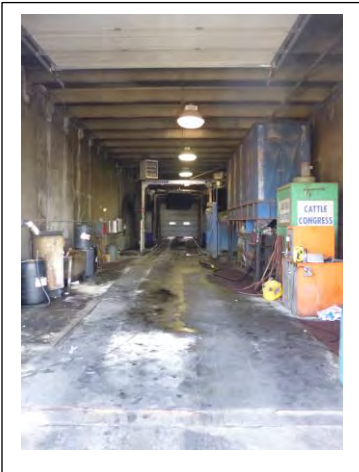
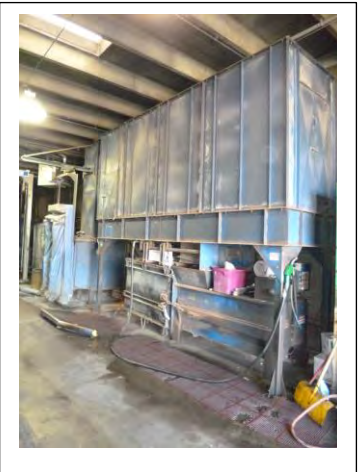
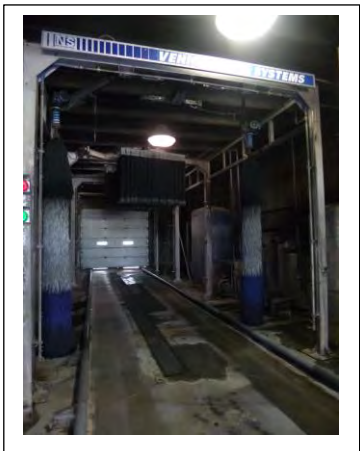
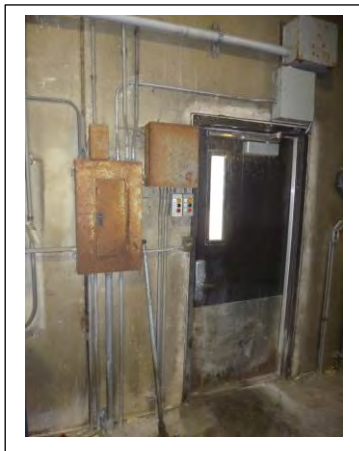
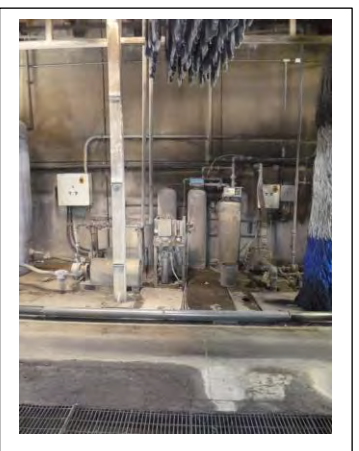
Bus Vacuum and Bus Wash Facility - Photos

**Condition Assessment
Bus Vacuum and Bus Wash Facility
Overall Condition Rating: 3.35714**

Substructure Subtotal	3
Shell Subtotal	3
Interiors Subtotal	Not Applicable
Conveyance Subtotal	Not Applicable
Plumbing Subtotal	4
HVAC Subtotal	Not Applicable
Fire Protection Subtotal	3.5
Electric Subtotal	4
Site Subtotal	3.5
Equipment Subtotal	2.5
Overall Conditional Rating	3.35714

Bus Vacuum	Marginal (2)
Bus Wash	Adequate (3)
Equipment Subtotal	2.5

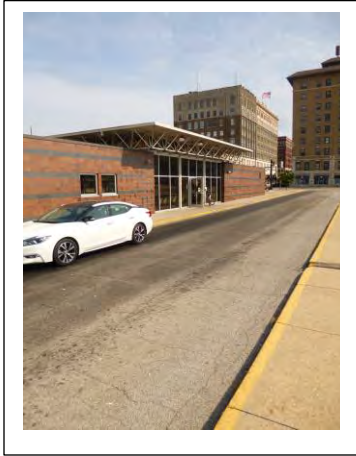
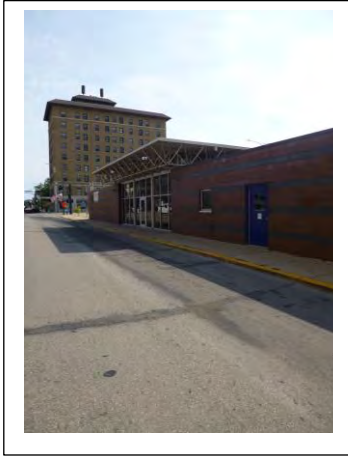
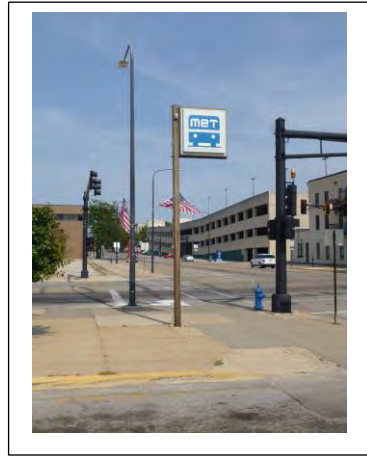
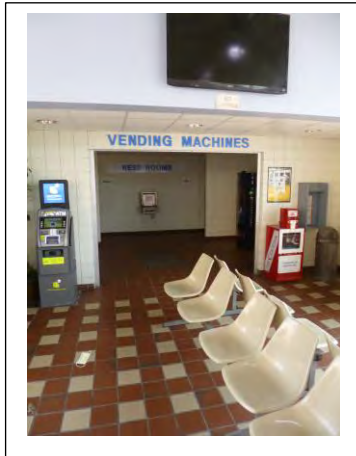
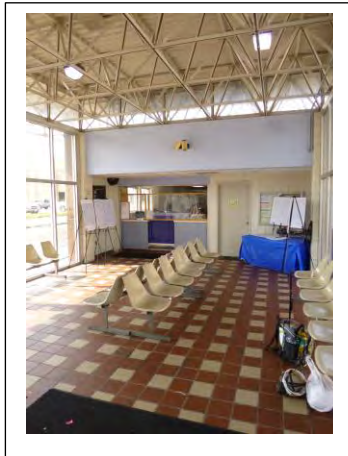
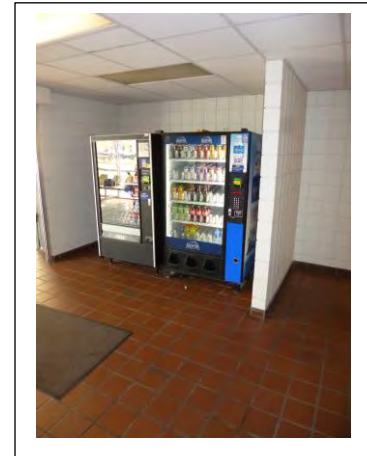
Central Transfer Station Photos

Condition Assessment Central Transfer Station Passenger Facility Overall Condition Rating: 3.65625

Substructure Subtotal	3
Shell Subtotal	3.5
Interiors Subtotal	3.5
Conveyance Subtotal	Not Applicable
Plumbing Subtotal	3.75
HVAC Subtotal	4
Fire Protection Subtotal	4
Electric Subtotal	4
Site Subtotal	3.5
Fare Collection Equipment	Not Applicable
Overall Conditional Rating	3.65625
